This cannabis grow facility needed protection that would last indefinitely. The initial floor coatings which were simply concrete densifier and a clearcoat had already failed only months into production, the room needed to be coated properly to bring it up to compliance with Health & Drug departments.

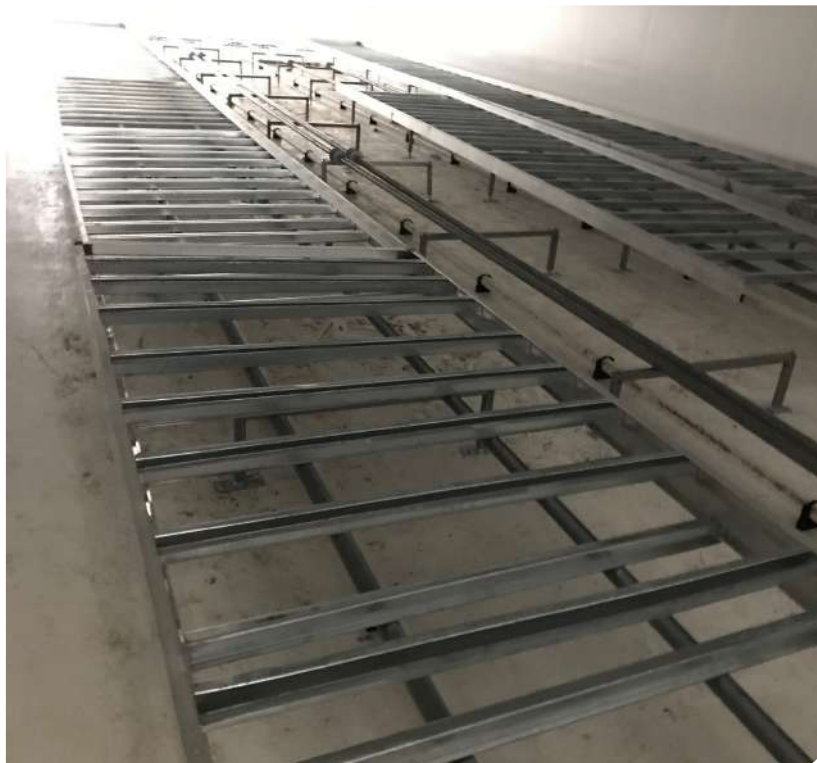
The racks had to be removed so that the job could be done properly. This allowed our installers easier access to the space and the ability to install the flooring faster.

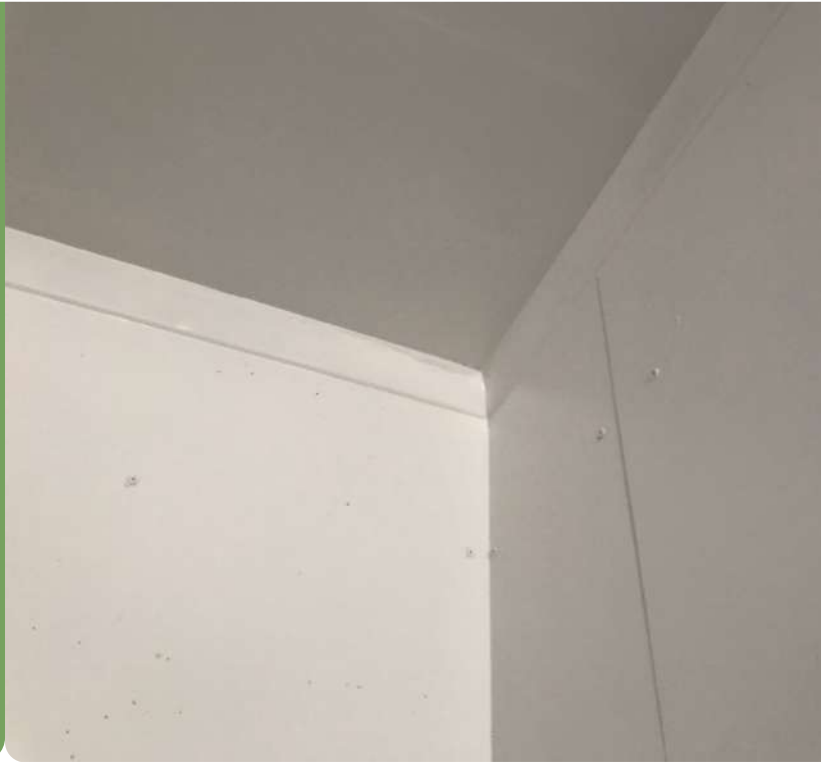
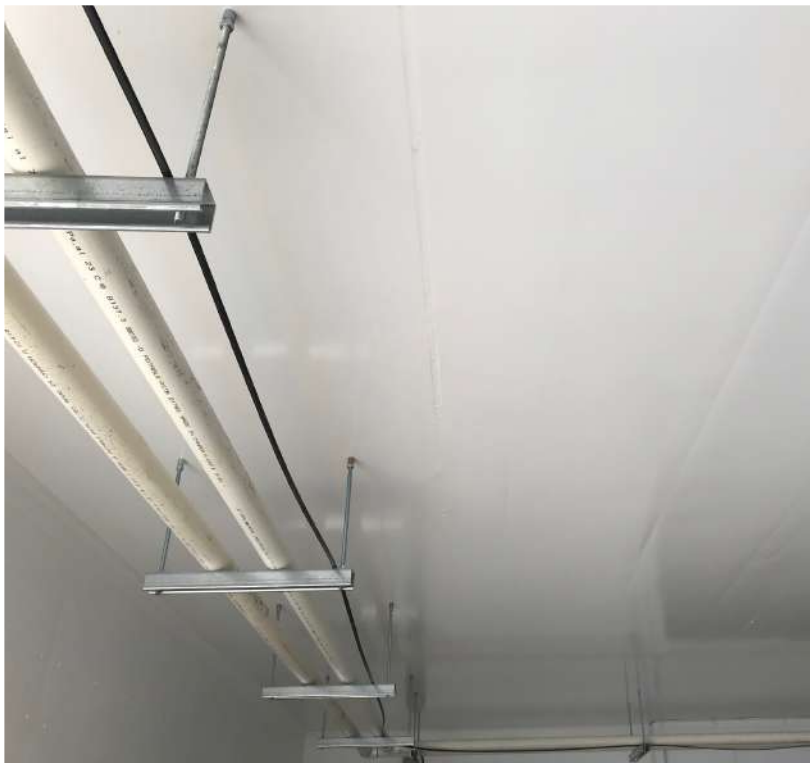
There were still voids prevalent in the wall and ceiling construction that would allow moisture to infiltrate in the form of screw holes and panel seams. These panels might look crisp and clean on the front-side after a wash; however, the problem happens behind the panel inside the wall itself. Spores of mould and bacteria can become airborne and affect the environment, staff, and products.

Any visible seams in the previously installed FRP panels needed to be filled with polyurethane and then coated over.

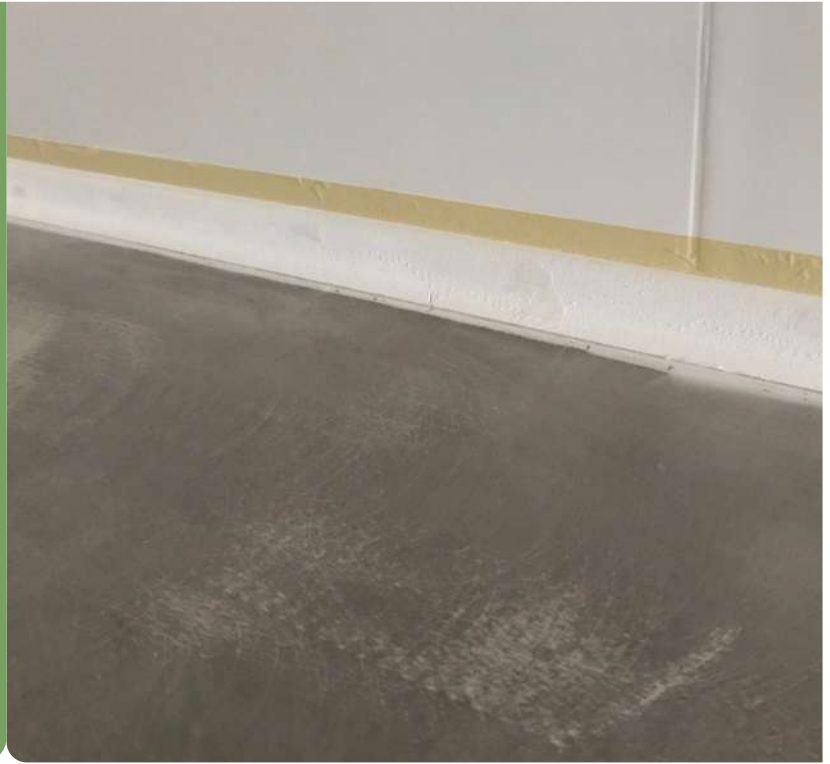
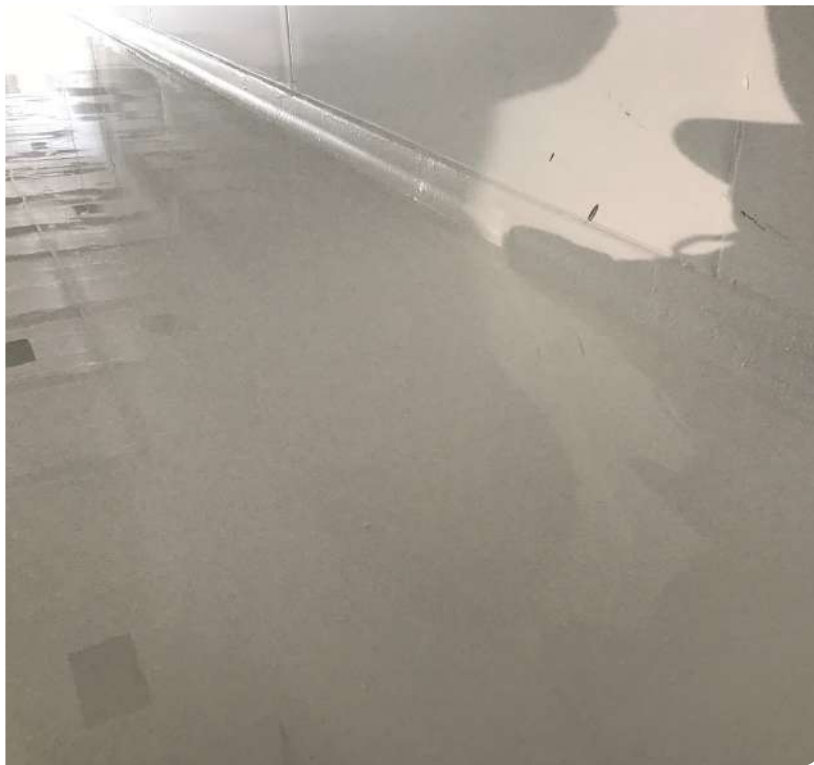
The first coatings were applied in order to remove any kind of visible seams from the rooms. This tied the walls into the floor creating one layer of protection over the entire space.

It was decided that we would carry the floor coating 4 inches up the wall and build a cove for the client to eliminate any possible seam or hard edge where the floor met the walls.

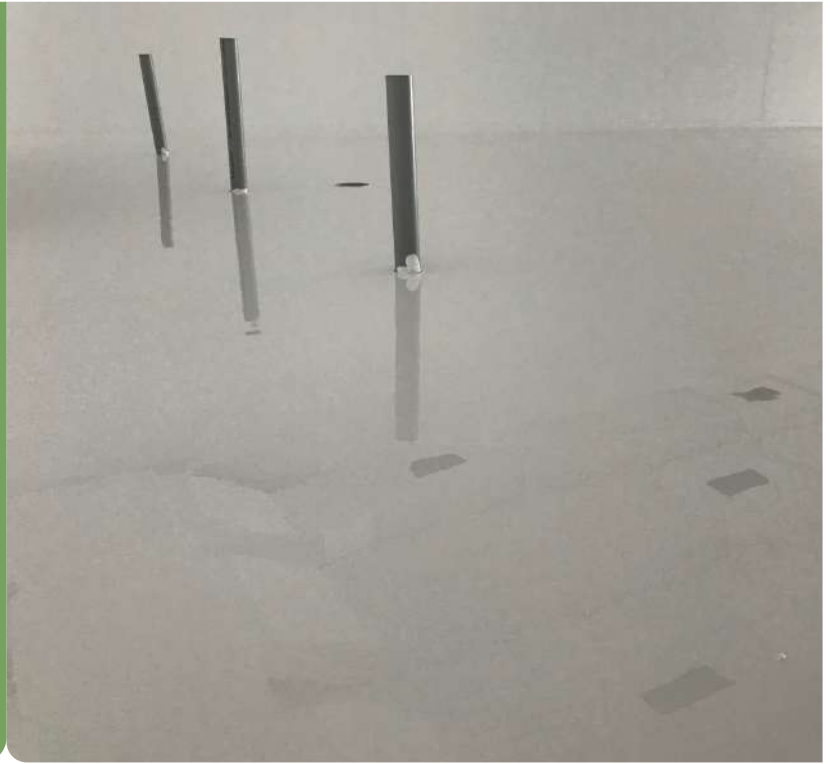
Even the air ducts and ventilation controls were incorporated into the room with the coatings to maximize light savings and to seal every possible space and void that moisture, removing any space where bacteria or mould could hide.

The floors as well as the walls needed to be highly reflective in order to reflect light back into the room and onto the client's product. This saved the client money on electrical costs that are spent to operate such a high demand operation.

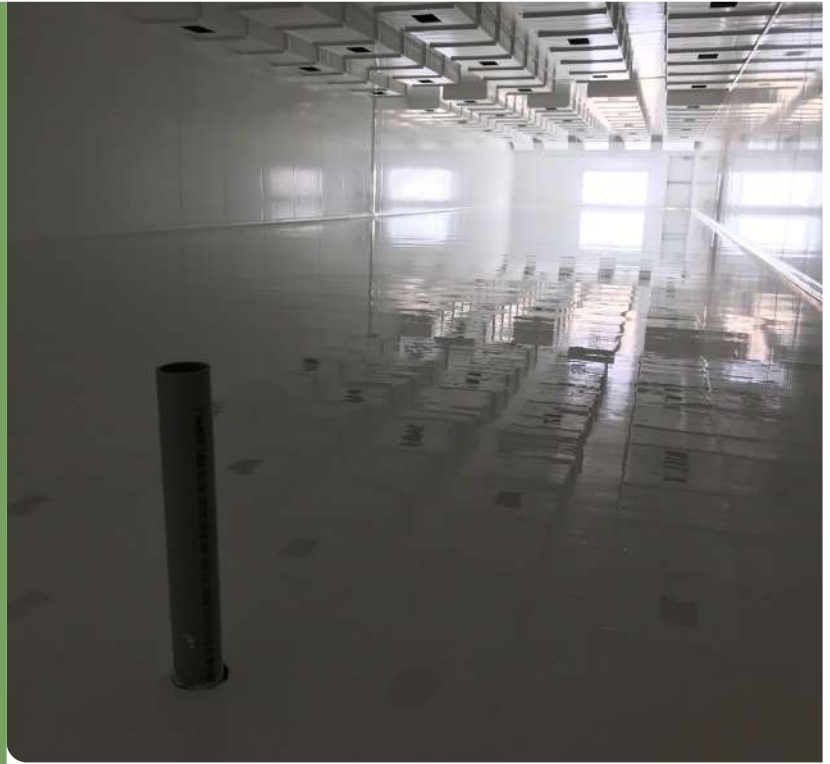
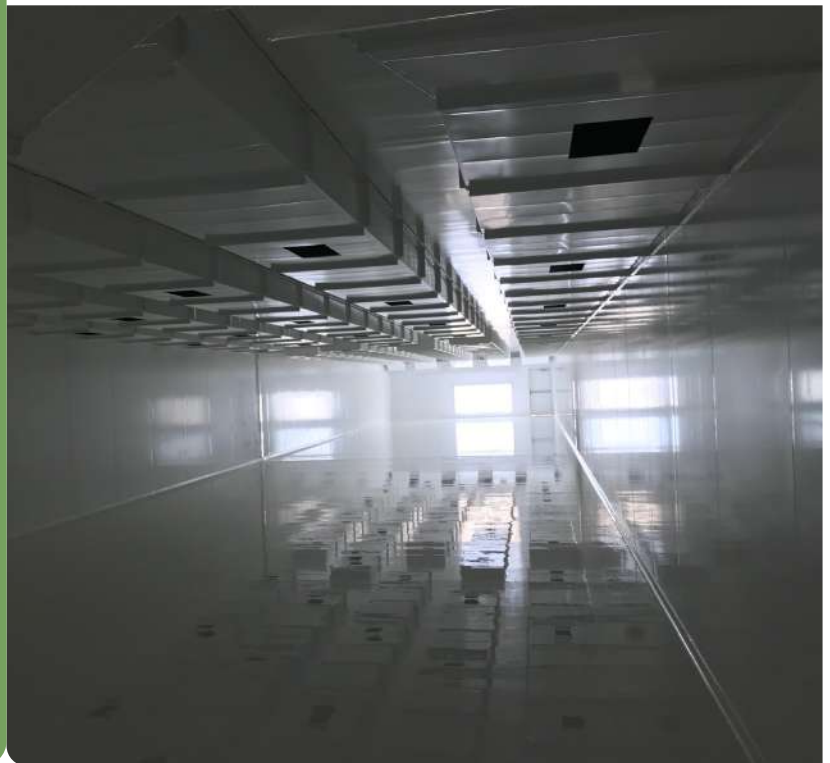
Now that the room is fully encapsulated, the client has an impenetrable surface that can be safely washed with pressure and cleaners. The final high gloss clear-coat was used to go on top the membrane layers of the walls, as a final protective layer of highly durable "armour" encased the entire room.

Now, this facility can be easily maintained and cleaned for years of growth cycles, meeting all the compliance standards in both Canada and the United States.
